## Case Study-I

•Transformer id: -	<b>T-1121</b>
•Transformer Make:-	<b>Kirloskar Electric company Ltd.</b>
•Rating of X'mer:-	<b>750 KVA</b>
•Maximum rated load current: -	<b>1000 Amps.</b>
•Customer name: -	<b>Visen industries</b>

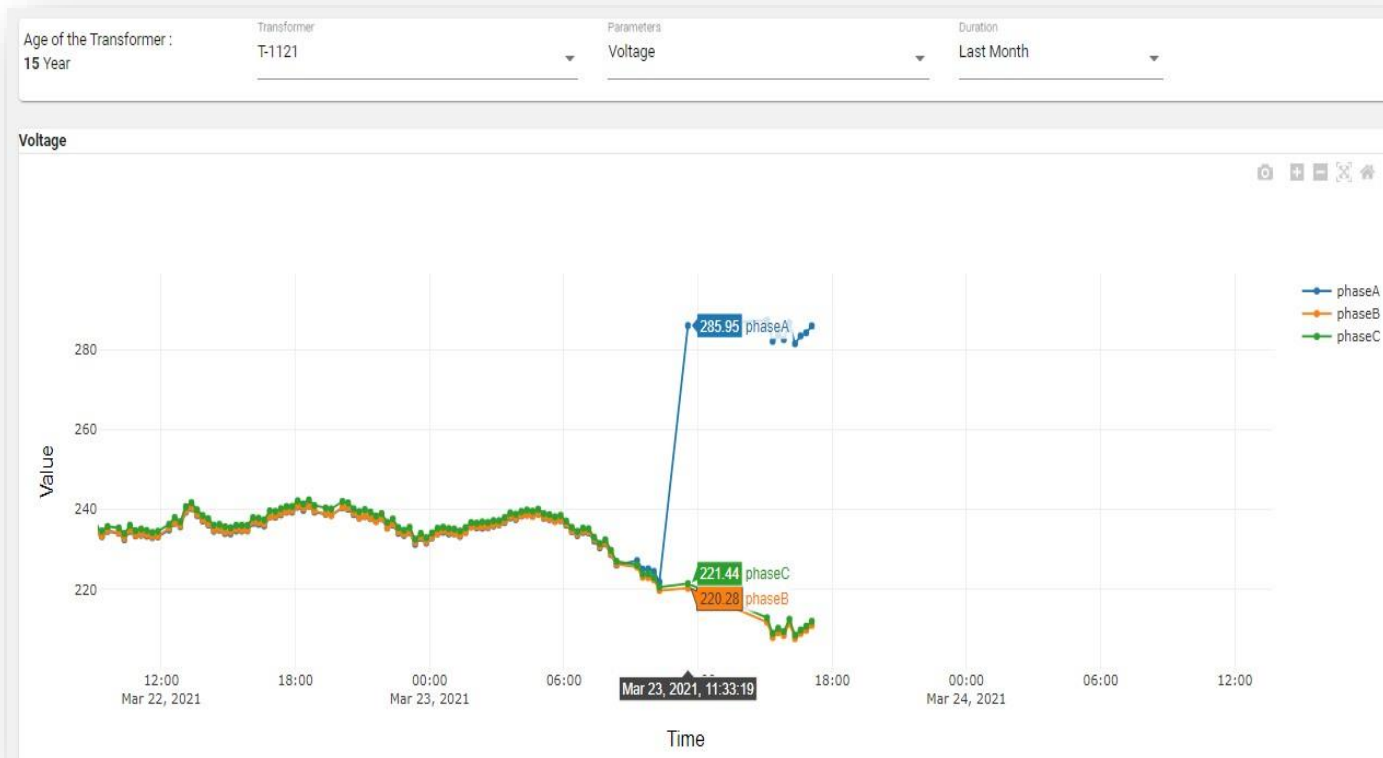
Transformers Rph to N voltage goes high, i.e. 287V. When this uncertainty happened BOLA device record this abnormality and instant notification is sent to respective maintenance person by the help of SMS and Email. Maintenance person immediately isolated the Transformer from the power system.

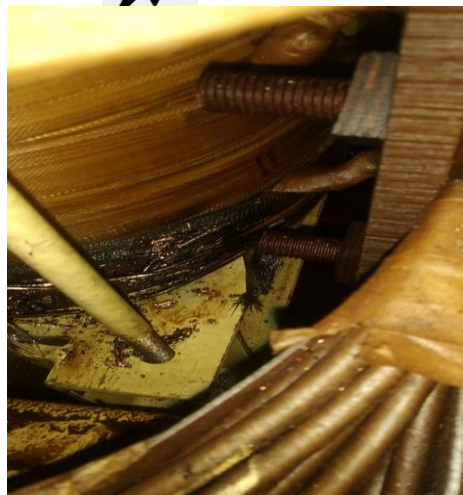
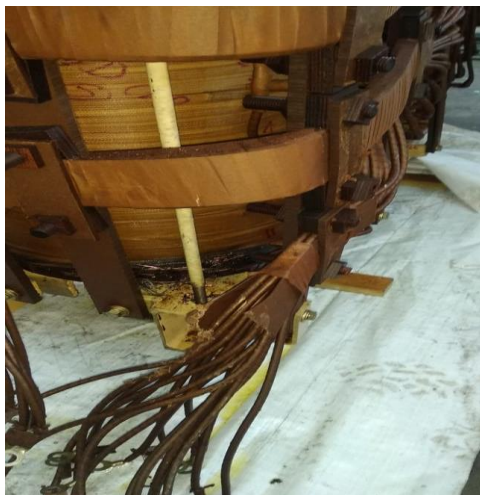
• After diagnosis of transformer short circuit failure in R phase observed.

• Following are the possible failure reasons:-

- Due to hot spot temperature creation.
- Decrease in dielectric strength of oil & weakened the insulation to rupture under normal voltage condition.

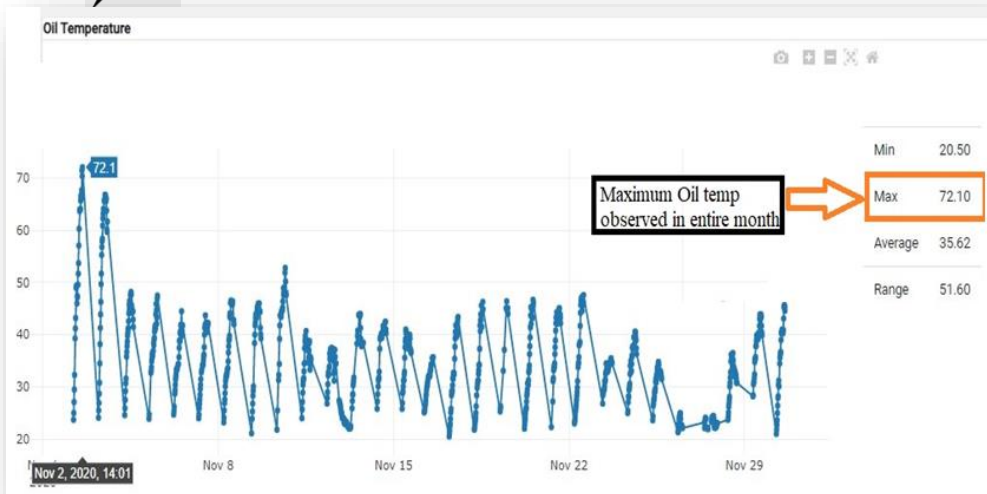
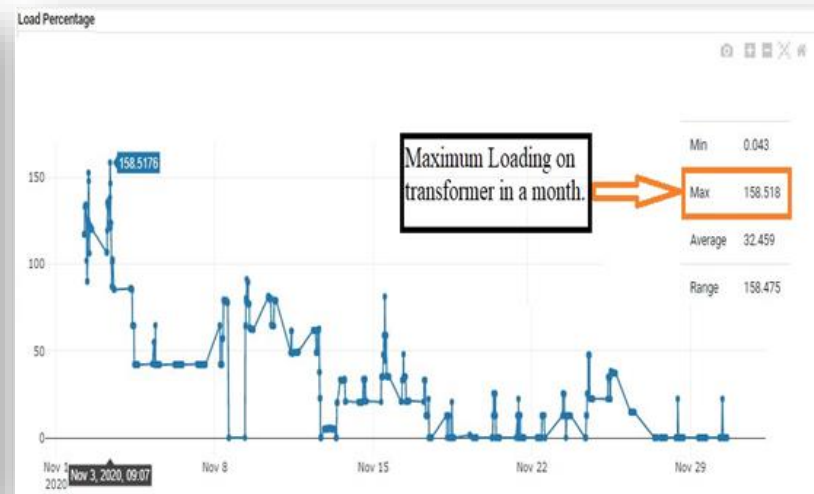
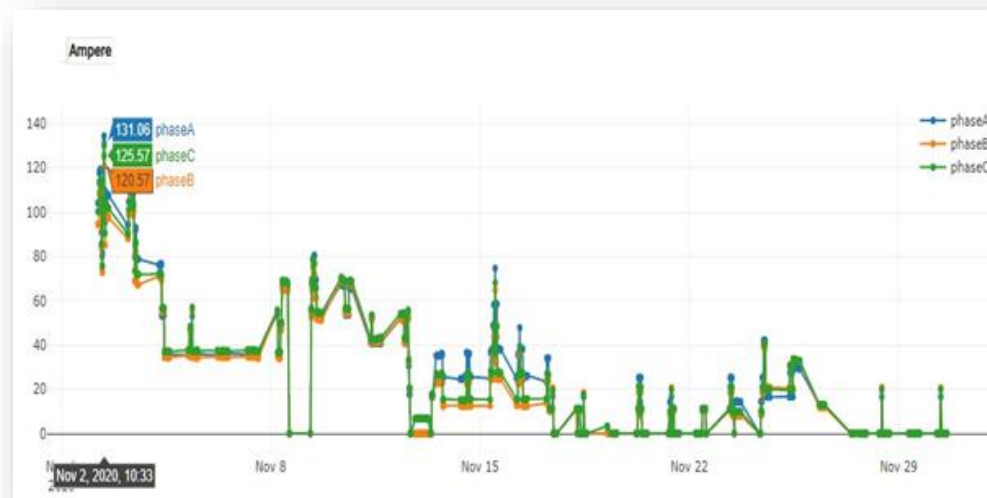
# Case Study-II – Before rectification

1. In Nov.2020, Oil temperature of transformer goes high continuously. Continuous rise in oil temperature will be hazardous for transformer, it will affect on winding of transformer.in this month we got notification via SMS and email of this uncertainty.
2. Following are some snaps which clearly gives idea, whenever transformer is overloaded, oil temperature goes high.

3. We informed customer regarding this uncertainty and given guidelines by the help of monthly analysis report to maintain transformer loading up to 70-80%.
4. Customer noted all the points and maintained transformer loading in next month. Some snap shots for reference.

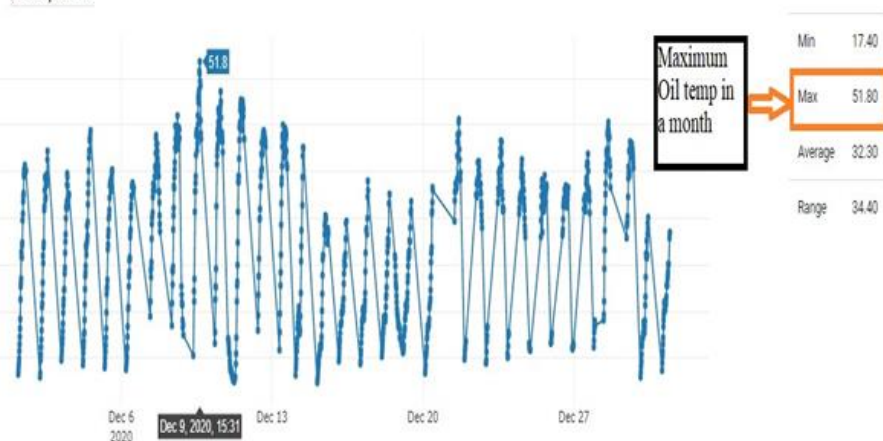
Oil Temperature

**Result: -This is how customer has maintained transformer loading and prevented the transformer from failing and that increased the life of the transformer.**

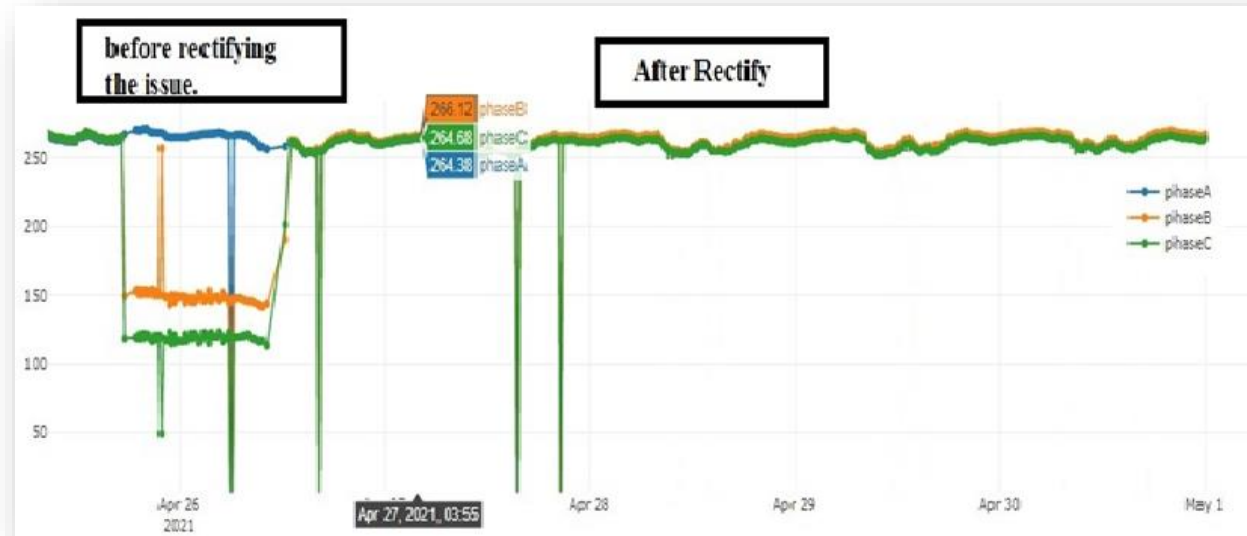
**Transformer id: T-1135**  
**Customer : KRYFS**  
**(Unit-II) Kherdi**

**With the help of KRYFS BOLA device maintenance team noticed the low voltage on LV side and were able to disconnect the Transformer on-time before any major damage. The damage could have been worse if not detected proactively by our BOLA**

1. Suddenly Voltage at LV drops and phase to neutral voltage goes below 50 V, this uncertainty capture by BOLA device. Same notification send by device to user maintenance person via SMS and mail. The maintenance Person physically visits the Power station and found some unwanted humming sound from transformer. Immediately he isolate the Transformer from the power system.

2. After diagnosis, at incoming side of transformer jumper connection was found loose. So, he tightened the jumper connection and rectified the problem and Transformer was charged.

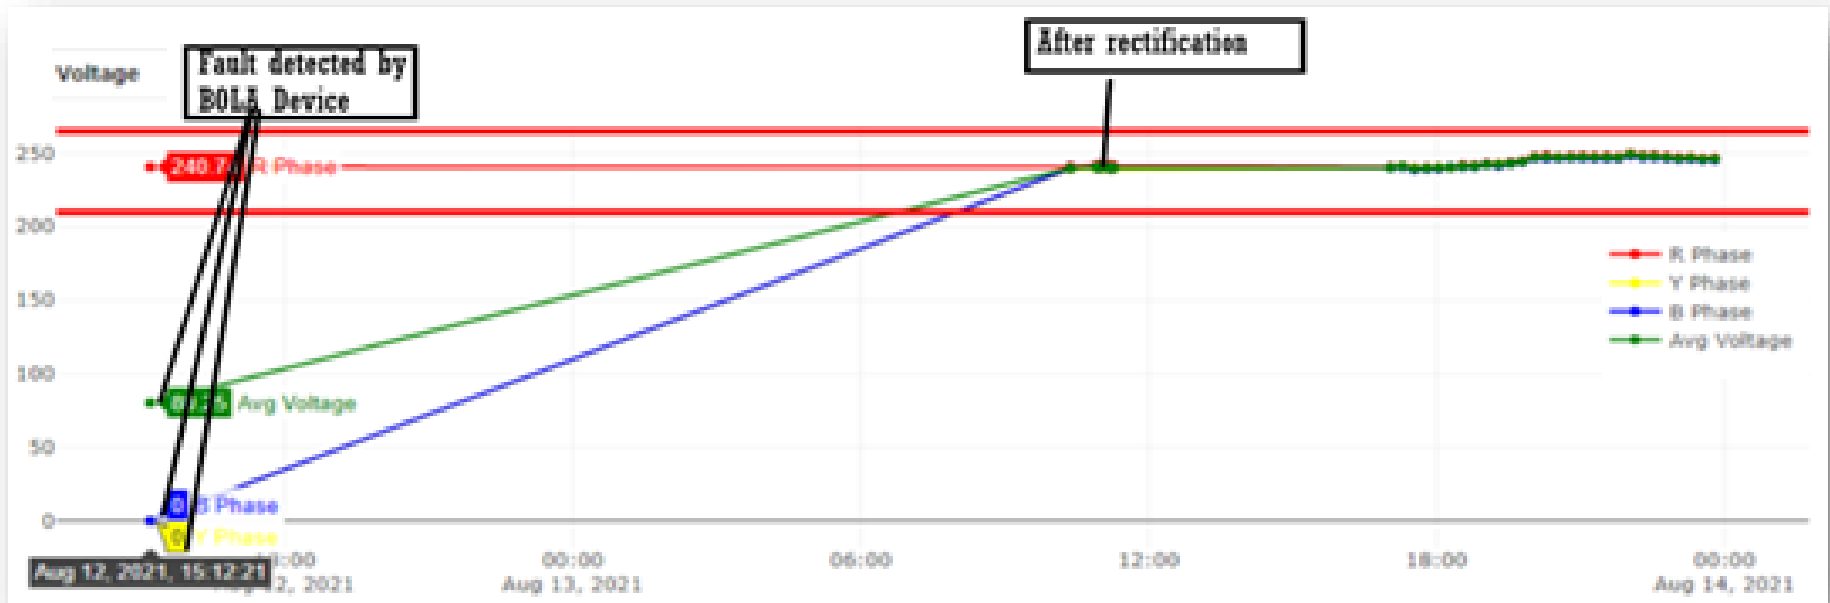
**Transformer id: T-1146**

**With the help of KRYFS BOLA device, the site engineer received an alert of Zero voltage on Y and B phase of Transformer LV side. Immediately they attended the site and disconnected the Transformer on time before any major damage. And also avoided the single phasing of the Transformer and gradually may have resulted in failure of the Transformer.**

1. On 12th August 2021 suddenly the Voltage between Phase B-N and Phase Y-N drops to zero voltage and this uncertainty was captured by BOLA device. Upon receipt of Alert notification was sent by BOLA device to user maintenance Engineer via SMS and mail, he physically visited the site and found some abnormal humming sound from transformer and immediately isolate the transformer from the power system.
2. After inspection they found that Drop out fuse (DO) was disconnected on the Incoming side of B and Y phase. They rectified the connection and charged the transformer on time.
3. Generally, such abnormality are detected after any outage complaint from the local peoples and may take hours to detect and rectify the issue. As a result into inefficient power supply and may gradually develop failure in the Transformer.
