## Case Study-I

•Transformer id: -	<b>T-1121</b>
•Transformer Make:-	<b>Kirloskar Electric company Ltd.</b>
•Rating of X'mer:-	<b>750 KVA</b>
•Maximum rated load current: -	<b>1000 Amps.</b>
•Customer name: -	<b>Visen industries</b>

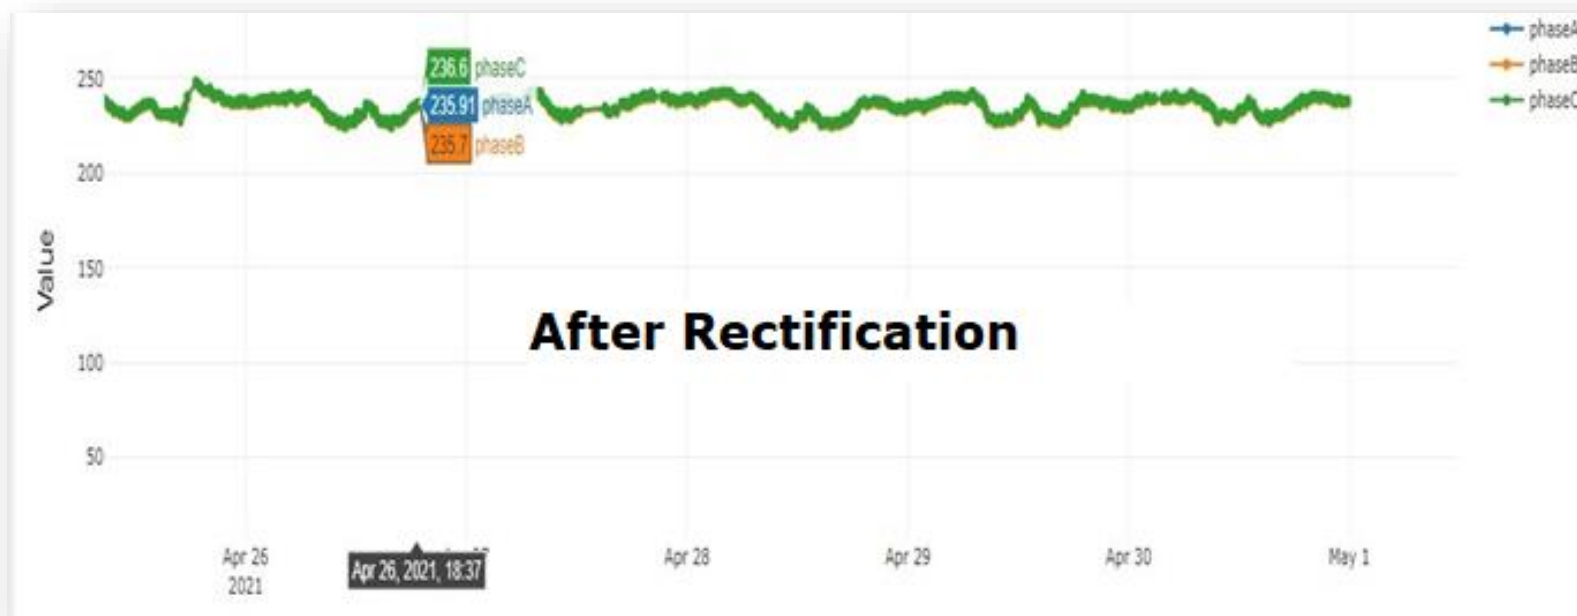
• After diagnosis of transformer short circuit failure in R phase observed.

• Following are the possible failure reasons:-

- Due to hot spot temperature creation.
- Decrease in dielectric strength of oil & weakened the insulation to rupture under normal voltage condition.
